Final Reclamation Inspection

Operator: KERR MCGEE OIL & GAS ONSHORE LP -
47120

Location ID: 331925

Inspection Photos
Location Name: MOSER FARMS *4-11
Location ID: 331925

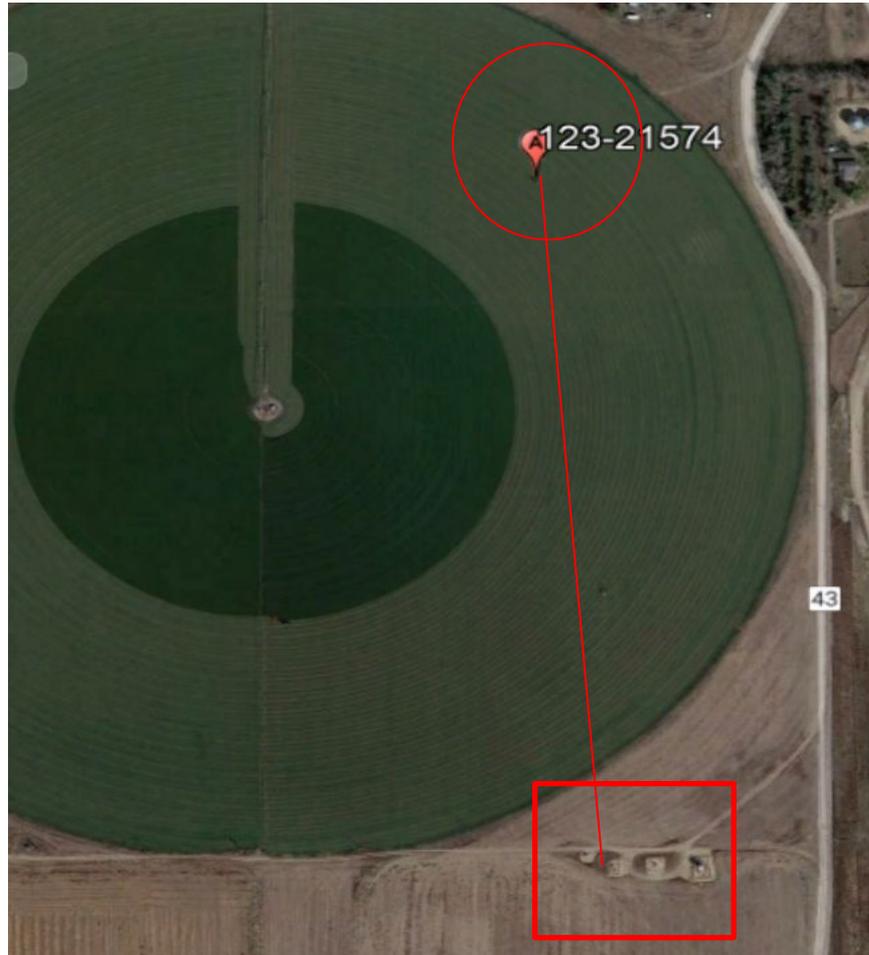
Photo 1. Google Earth aerial imagery taken 10/2015 during active operations. Photo illustrates the well location (red circle), tank battery (red square), and flowlines (red line).

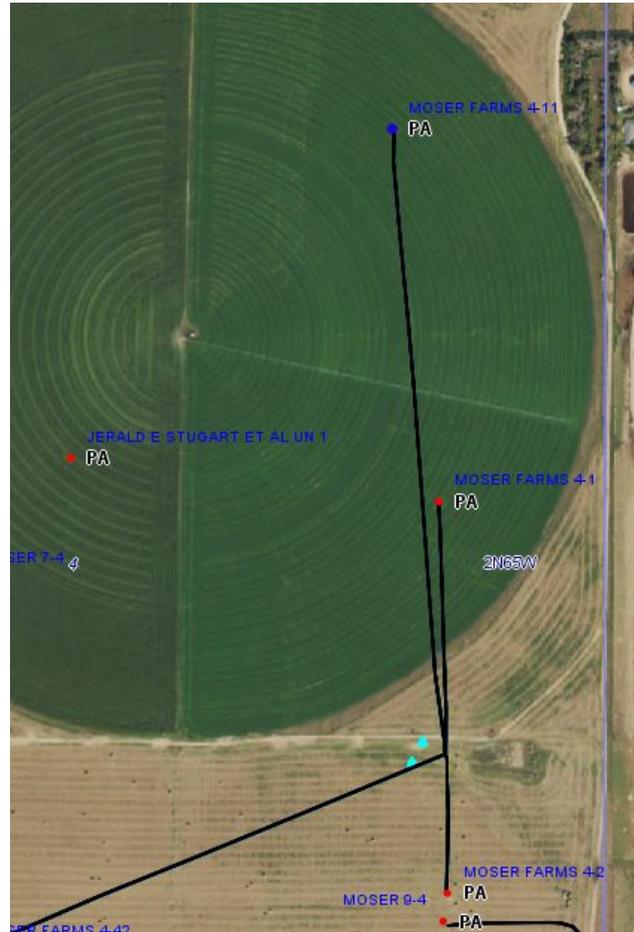
Photo 2. COGCC Online Map aerial imagery 2019 with subject well (blue dot), related wells (red dots), tank battery (southeast) and flowlines (black lines).

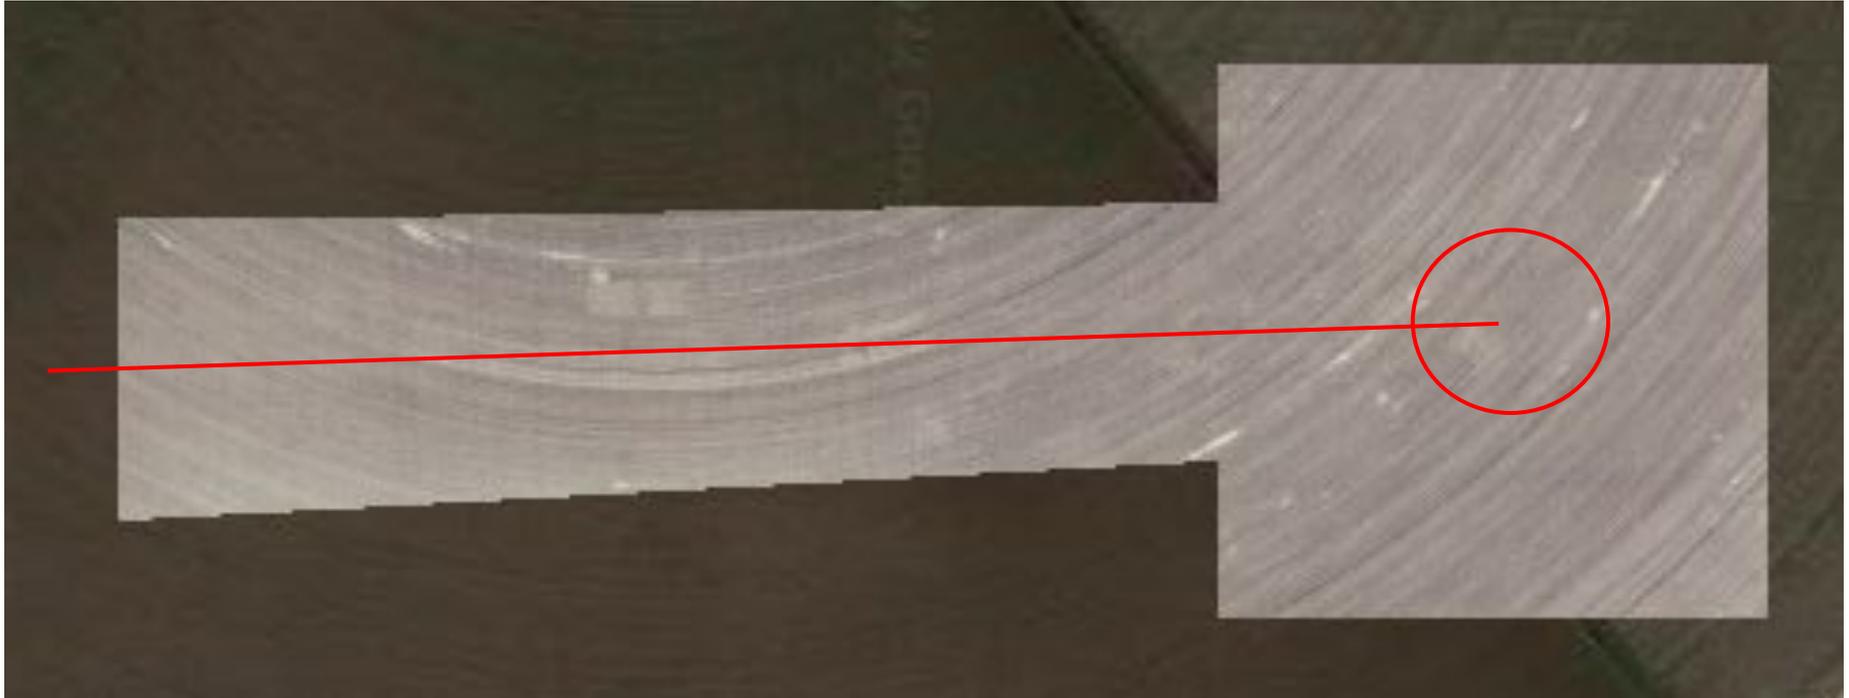
Photo 3. Orthomosaic drone aerial imagery taken from 200 ft (Oct. 2022). Illustrates harvested crop on and around the well location (red circle) and flowlines (red line). No access road visible. Tank Battery is addressed in Location 327566 report.

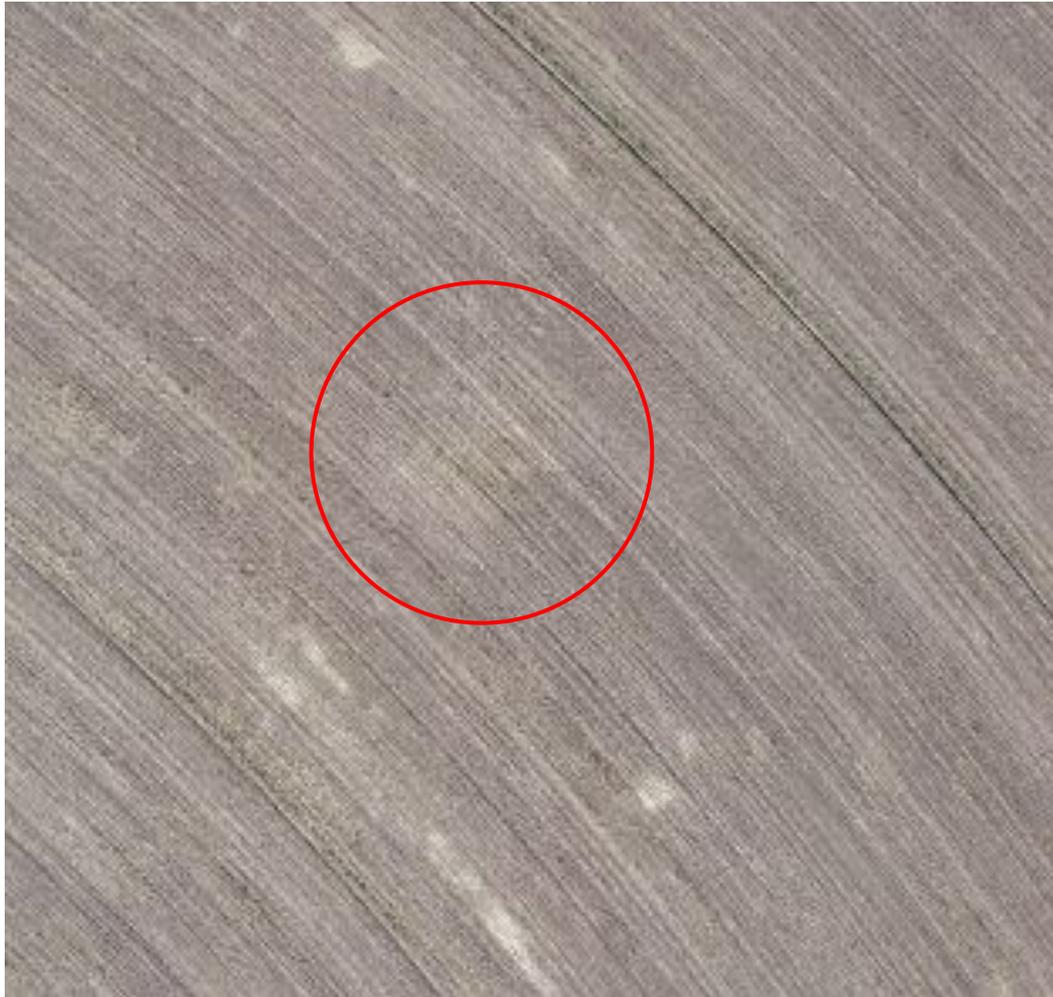
Photo 4. Zoomed in Orthomosaic taken from 200 ft (Oct. 2022). Illustrates harvested crop on and around the well location (red circle). Appears similar to rest of area, however crop height cannot be fully evaluated. Another inspection is required when crop is actively growing.
