**Operator: BONANZA CREEK ENERGY OPERATING COMPANY LLC**

**Location Name: Crow Valley 7-62-32 1M**

**Loc ID: 422253**

**Inspection: 696305496**

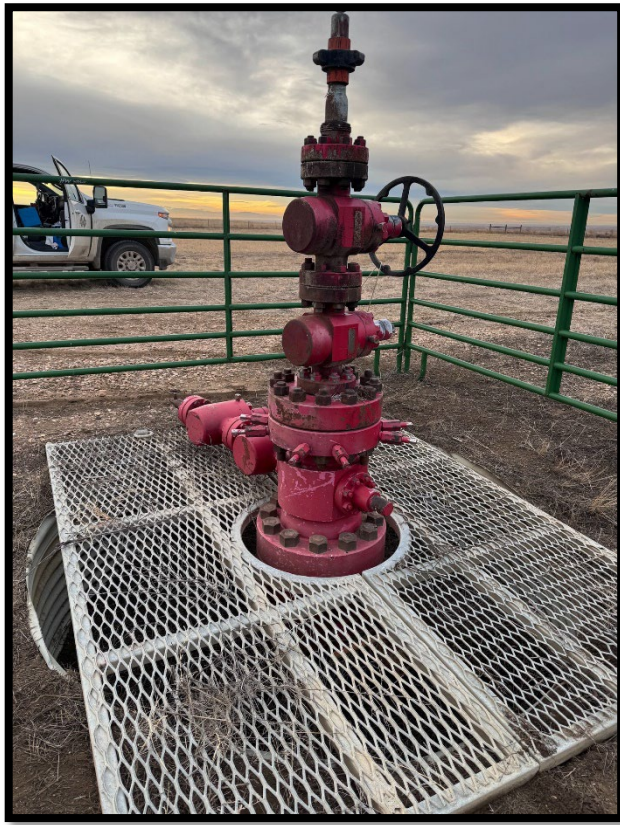
**Exhibit A**

**CA:** Unused Pipe at Well Site; see photos. Comply with Rule 606.

**CA Resolution:** Operator has reported that all identified/unused pipe have been appropriately removed from the location to comply with Rule 606.

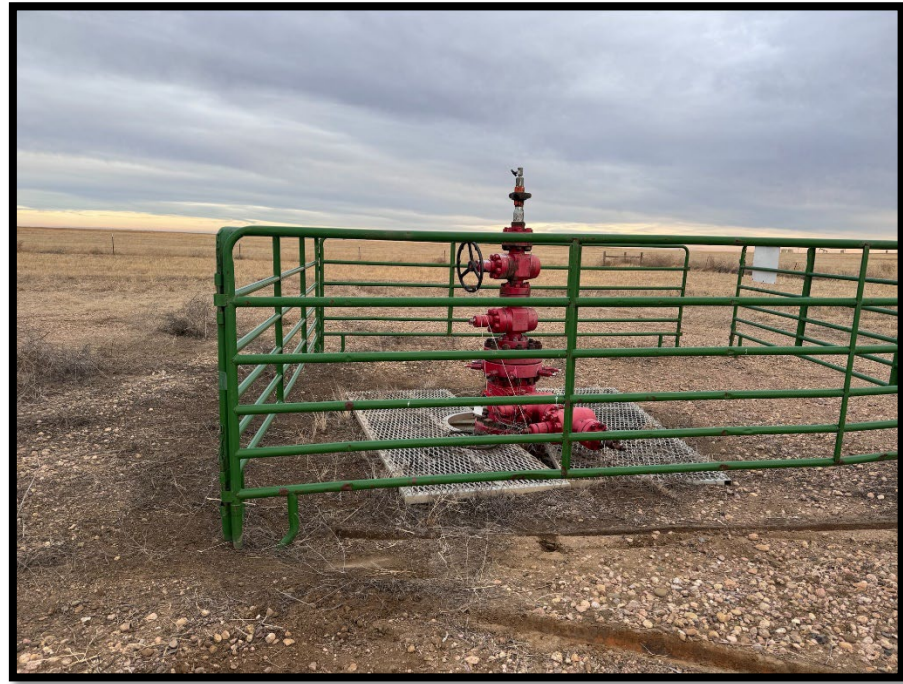
**Exhibit B**

**CA:** Tumbleweed Debris at Wellhead; see photos. Comply with Rule 606.

**CA Resolution:** Operator has reported that tumbleweed debris at the Wellhead has been cleared/removed to comply with Rule 606.
