Location Drawing

VISIBLE IMPROVEMENTS SKETCH SEEBASS G05-25

SECTION 5, TOWNSHIP 4 NORTH, RANGE 65 WEST OF THE 6TH PRINCIPLE MERIDIAN

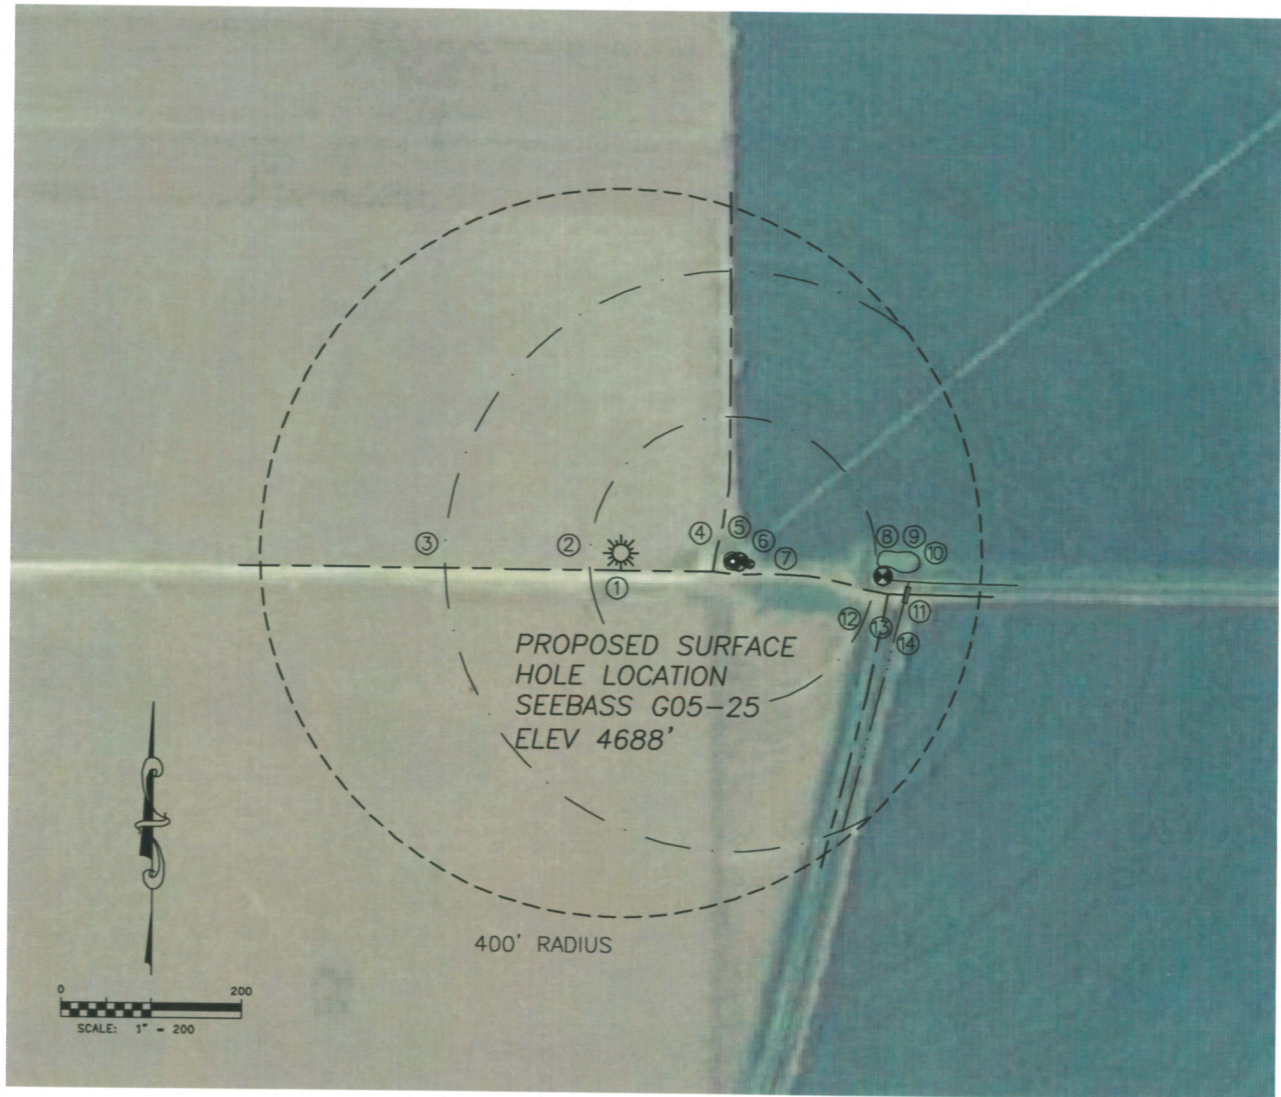
①
CENTERLINE
FIELD ROAD
19' SOUTH

②
PIVOT TRACK
35' WEST

③
PIVOT TRACK
195' WEST

④
CENTERLINE
FIELD ROAD
105' EAST

⑤
CENTER PIVOT
124' EAST

⑥
WATER WELL
131' EAST

⑦
ELECTRIC
CONNECTION
136' EAST

⑧
WATER WELL
291' EAST

⑨
CONCRETE
DITCH
295' EAST

⑩
POND
290' EAST

⑪
CONCRETE
BOX CULVERT
317' SE
(DITCH CROSSING)

⑫
PIVOT TRACK
278' SE

⑬
CENTERLINE
FIELD ROAD
298' SE

⑭
IRRIGATION DITCH
317' SE
