Database File: icehouse72211b.db
Dataset Pathname: pass2.1
Presentation Format: cbldig
Dataset Creation: Fri Jul 22 11:52:37 2011 by Calc Open-Cased 110302
Charted by: Depth in Feet scaled 1:240

Calibration Report

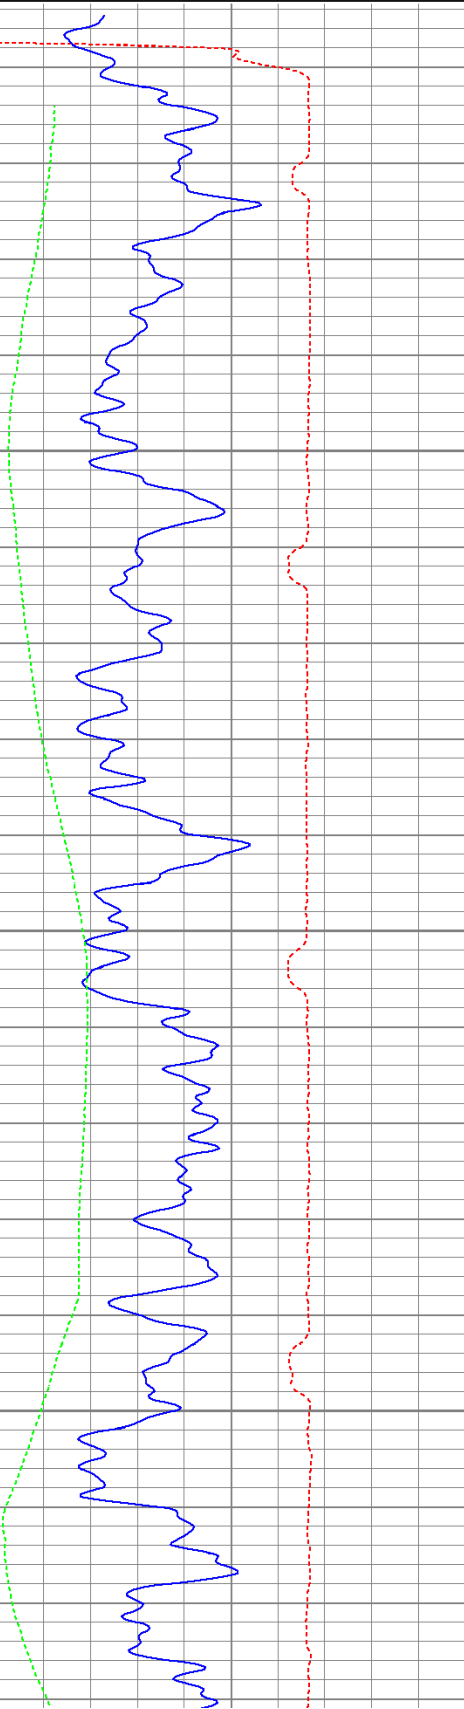
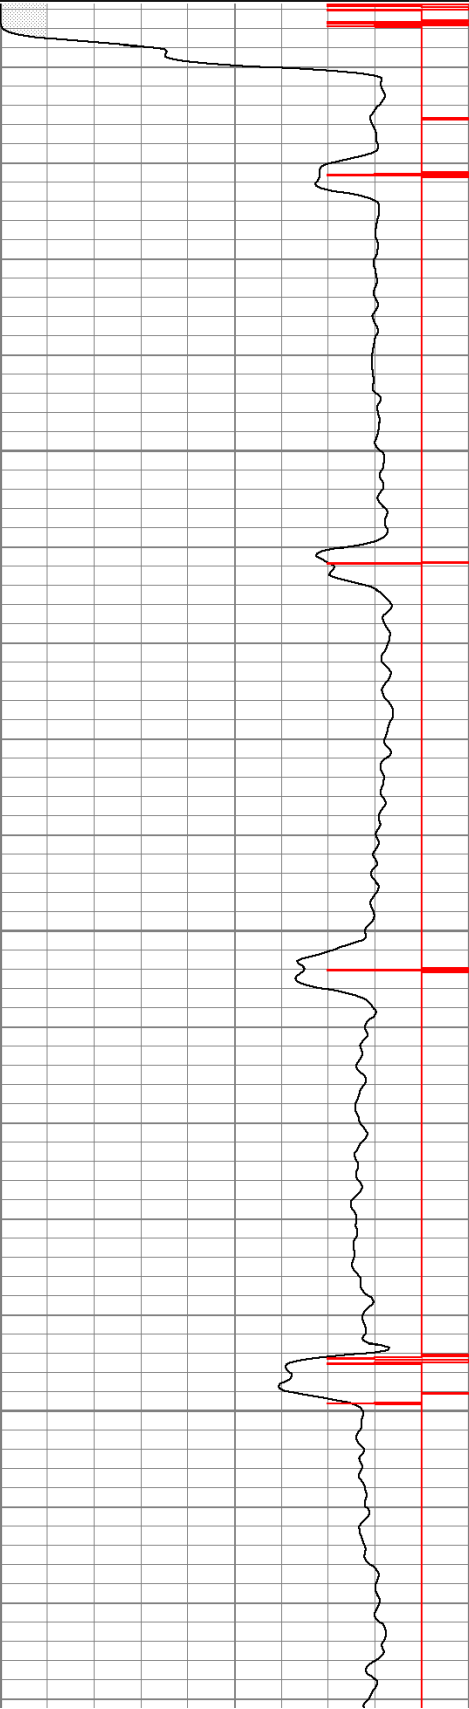
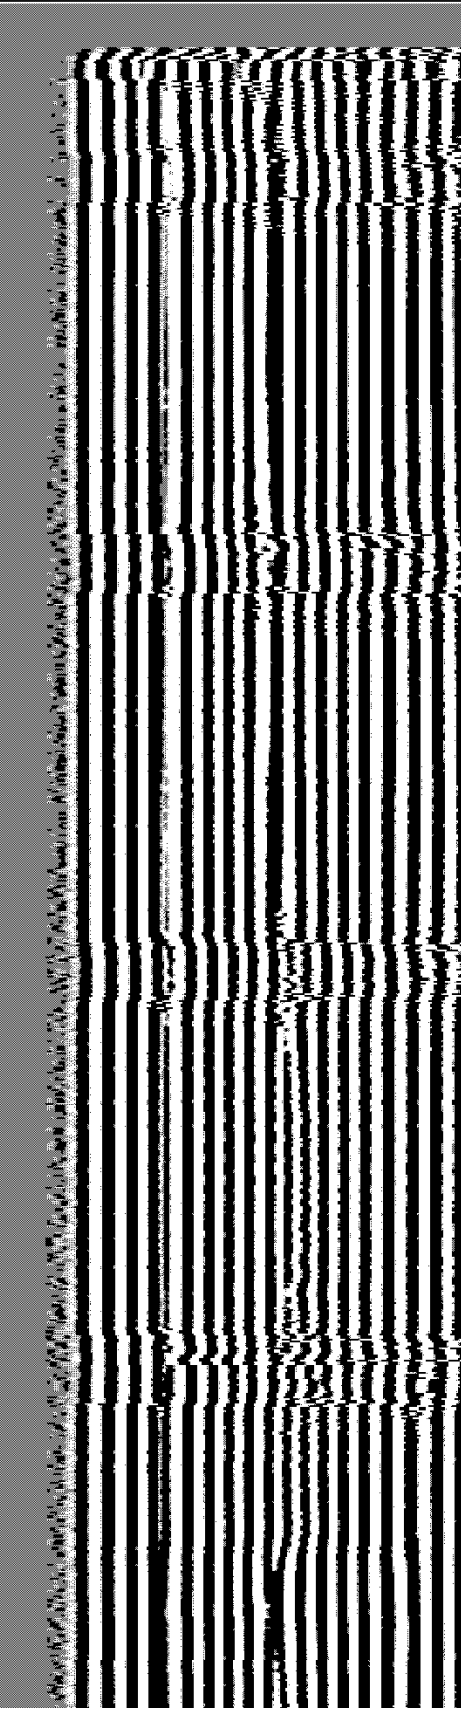
400	Travel Time (usec)	200
0	GR (GAPI)	200
0	DEVI (°)	10

0	Amplitude (mV)	100
9	Collar Locator	-1

200 Variable Density 1200

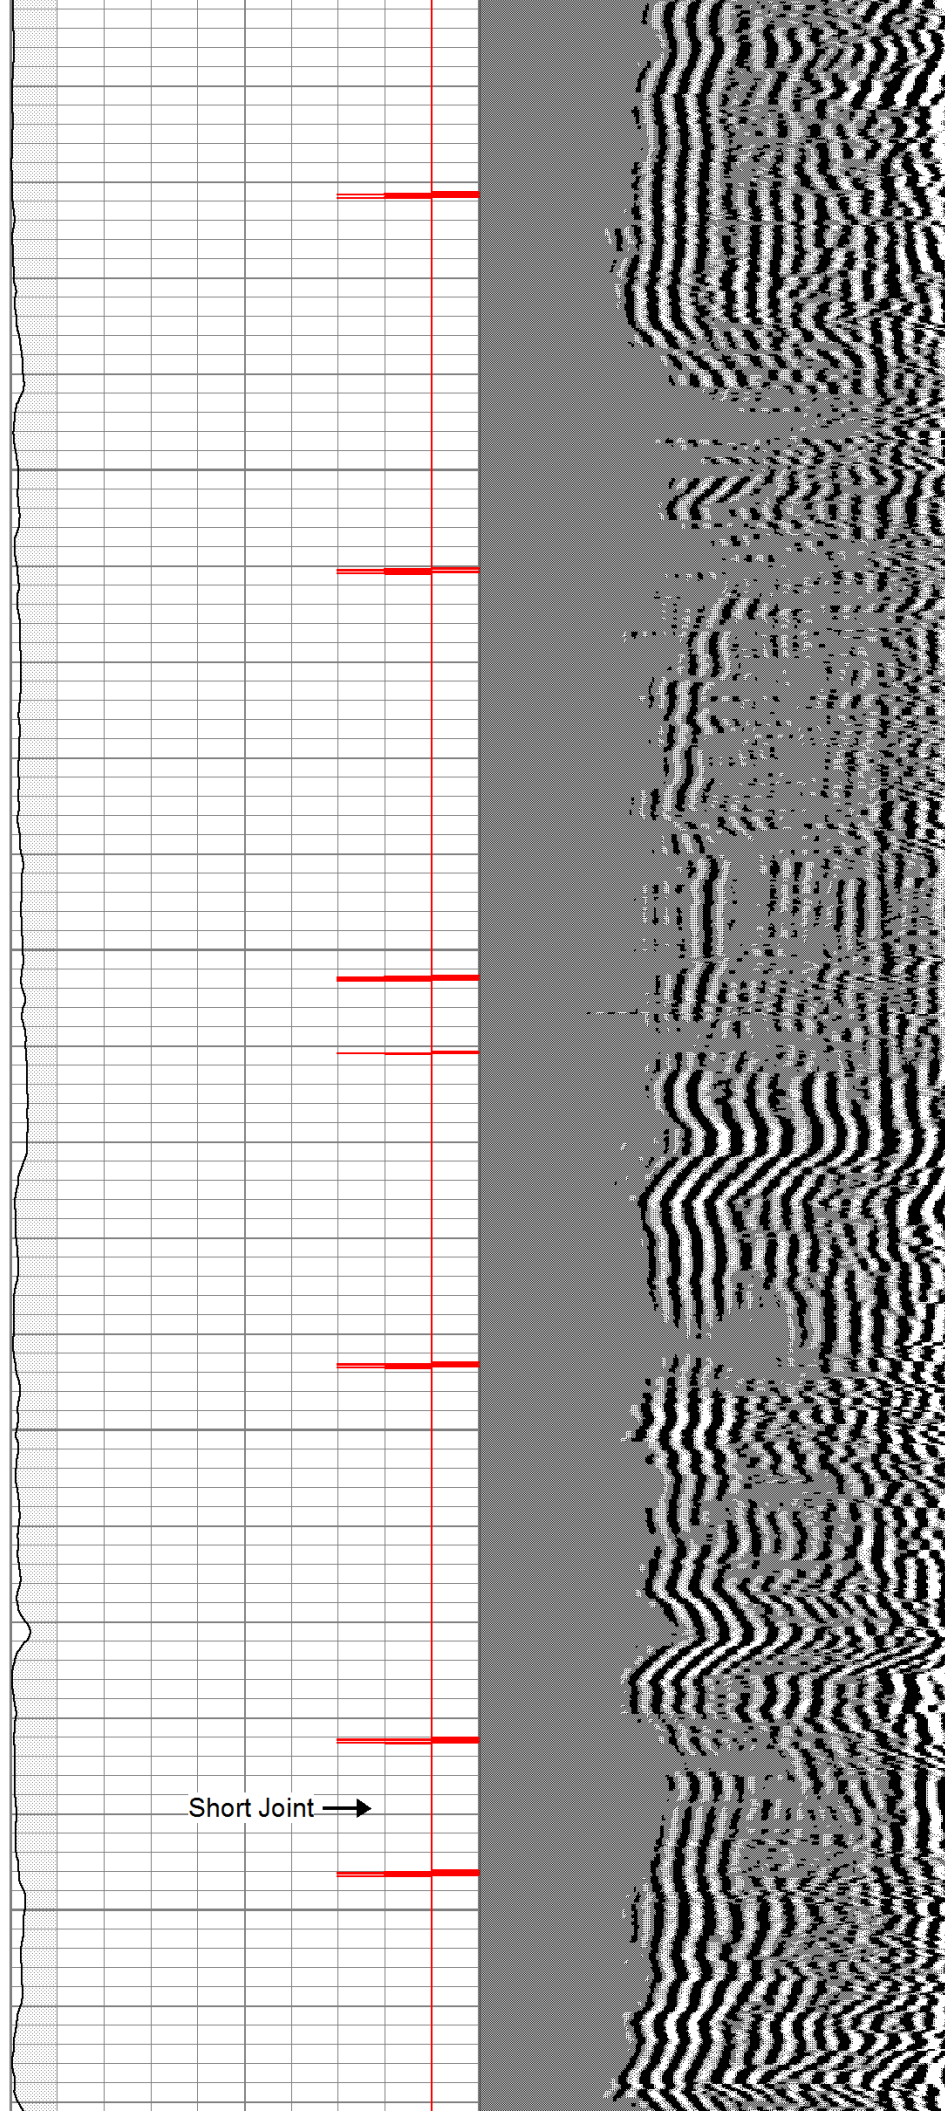
Short Joint →
