Well Name: Bull Creek Federal 1 **API #** 05-007-06122
Inspection Number: 693901794

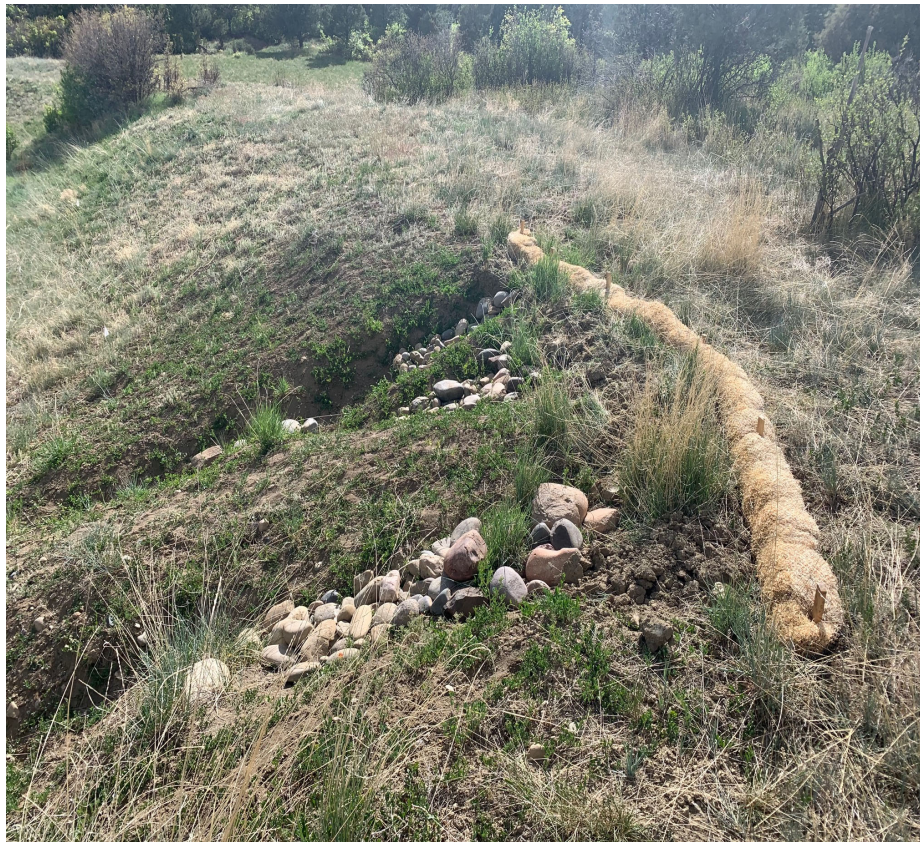
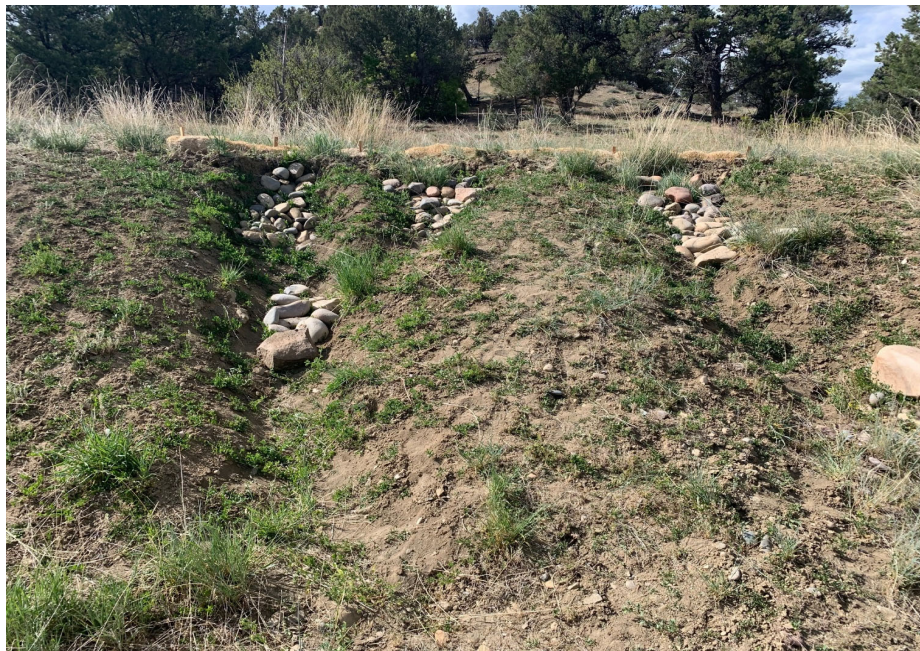
Corrective Action: Erosional channels are forming within the northeastern cut-slope. Sediment deposition observed at the toe of the slope.
Stormwater controls need to be installed to stabilize erosion.

Action Taken: Installed wattles on slope and rock dams along erosion channels.
