# Inspection Photos and Issue Report

Operator: GENESIS GAS & OIL COLORADO LLC  
- 10384

Location ID: 414116  
Rio Blanco County, CO

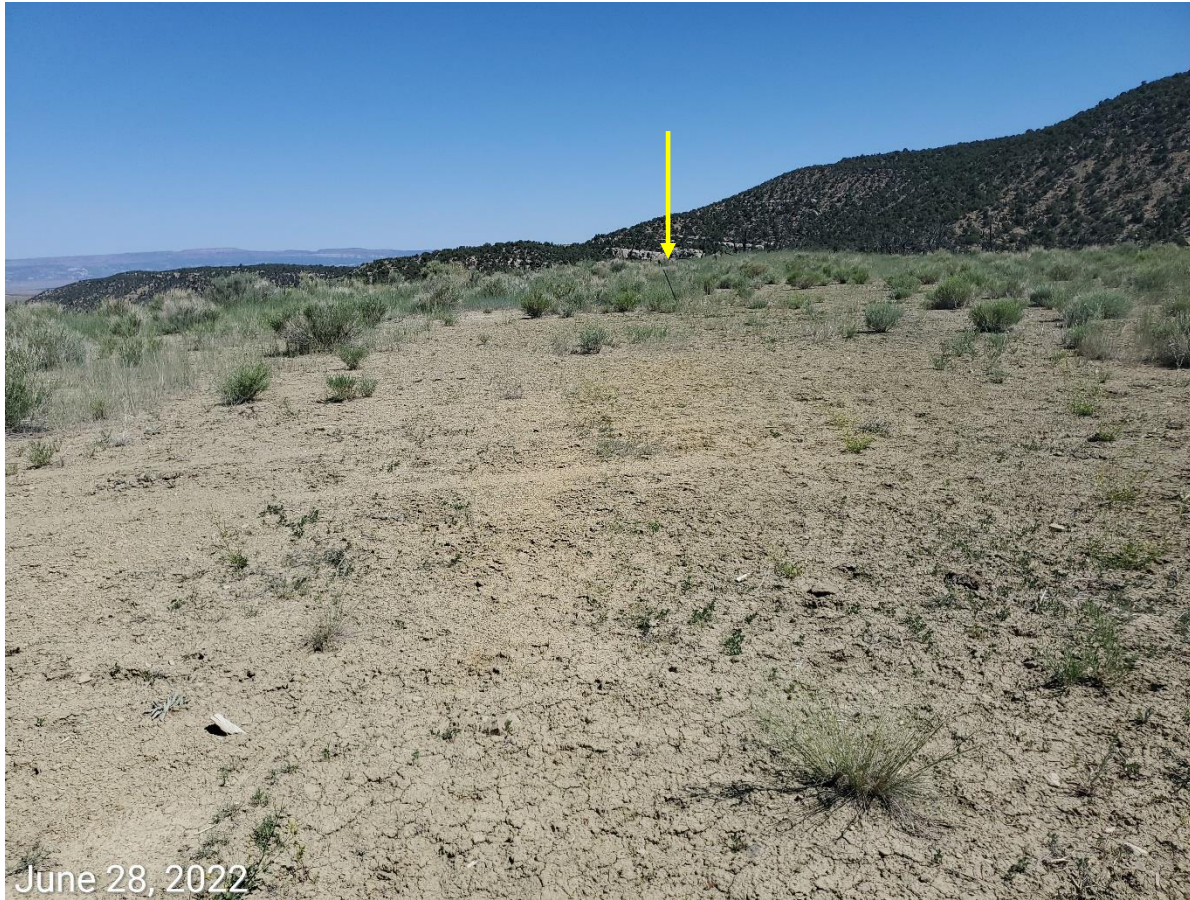
**Photo 3:** Photo taken from the Location, facing north. Photo shows well pad and well marker; pad has been constructed, however well has not been drilled; all Form 2 and Federal “permits to drill” on file for the Location have expired, and the Location is subject to Final Reclamation requirements. Submission of additional permits does not waive compliance with 1004 requirements.

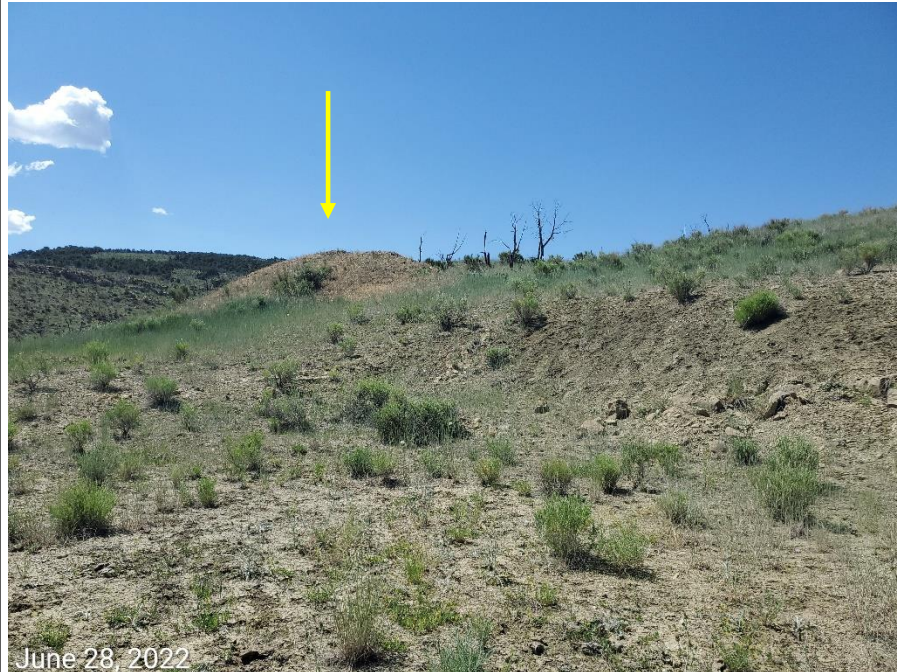
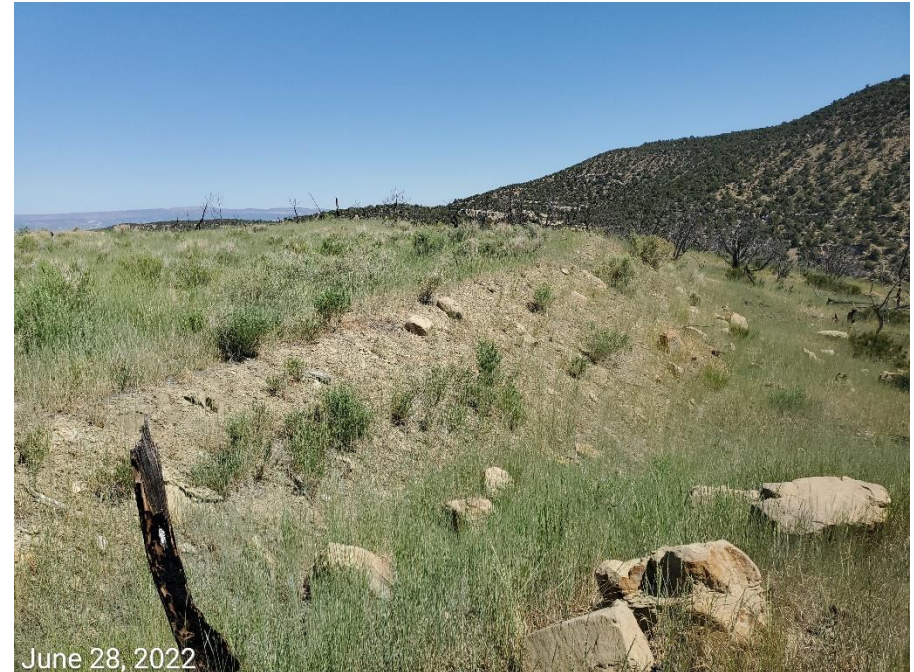
**Photo 2:** Photos showing cut and fill slopes of the Location, as well as what appears to be the topsoil stockpile (arrow).

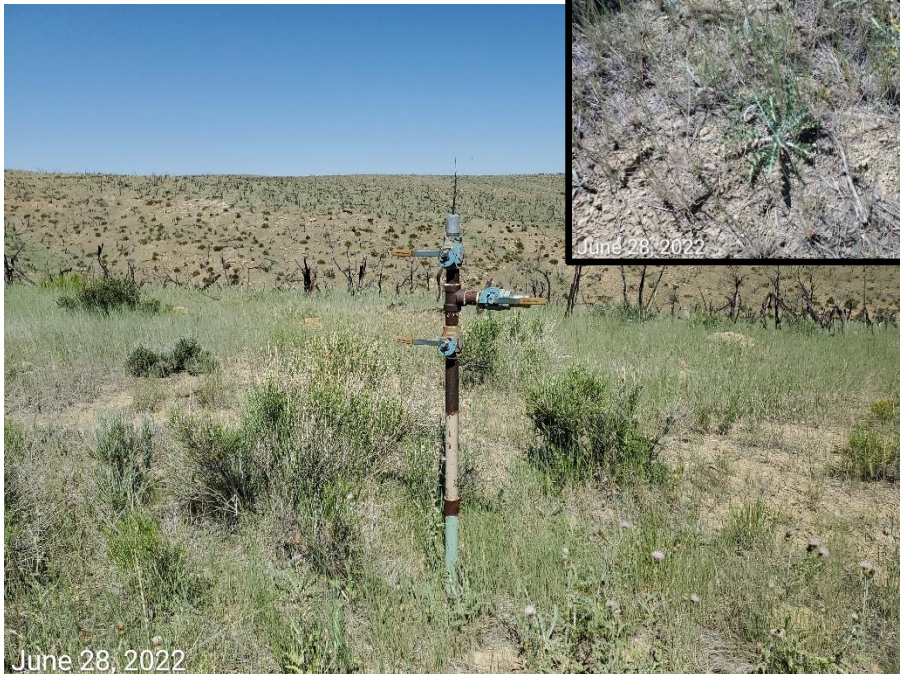
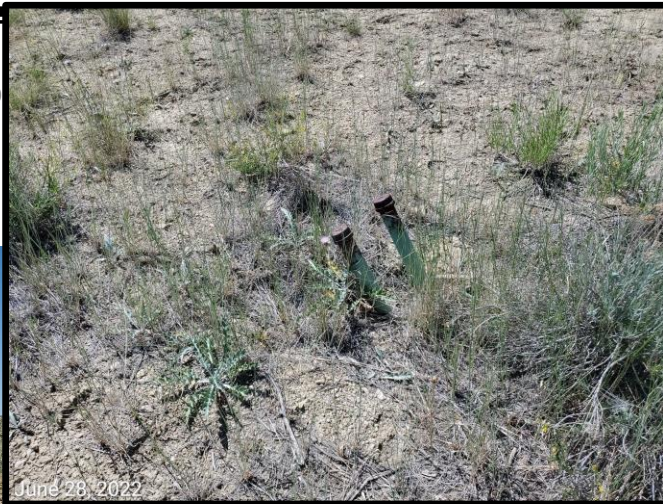
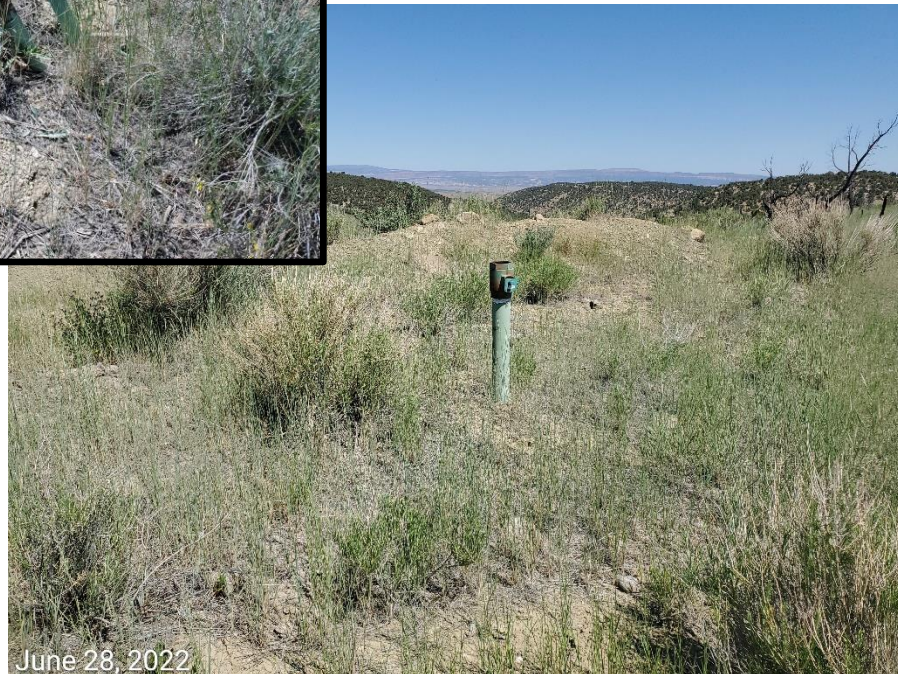
**Photo 3:** Photos showing various pipe equipment observed on the Location; well has not been drilled.
