Inspection Photos

API: 067-09196

Operator: FOUR CORNERS ENERGY LLC

Inspection Date: 11/18/2022

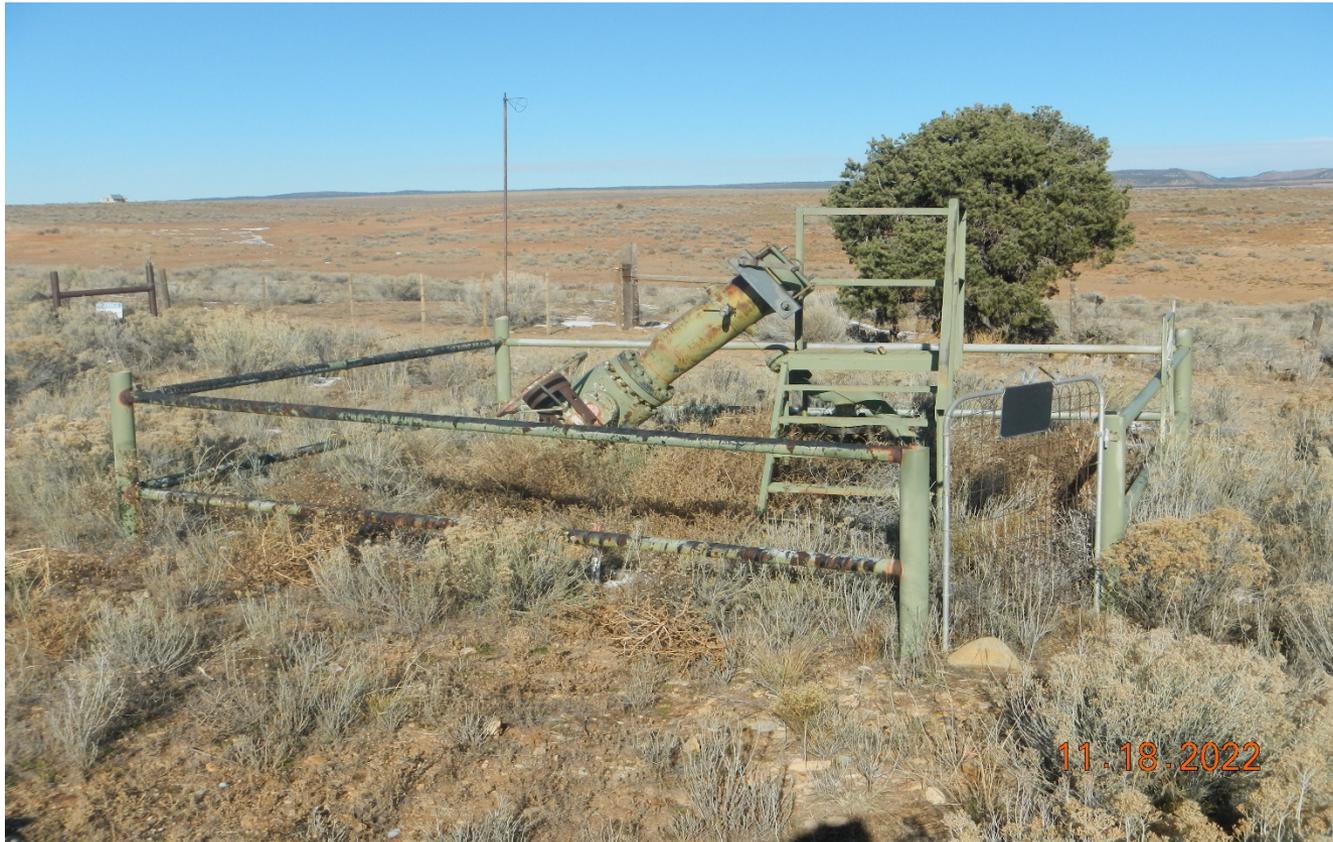
Photo 1. There is a pig launcher that remains approximately 1900' NW of the location. All equipment needs to be removed. Lat/Long:37.15495,-108.17333.

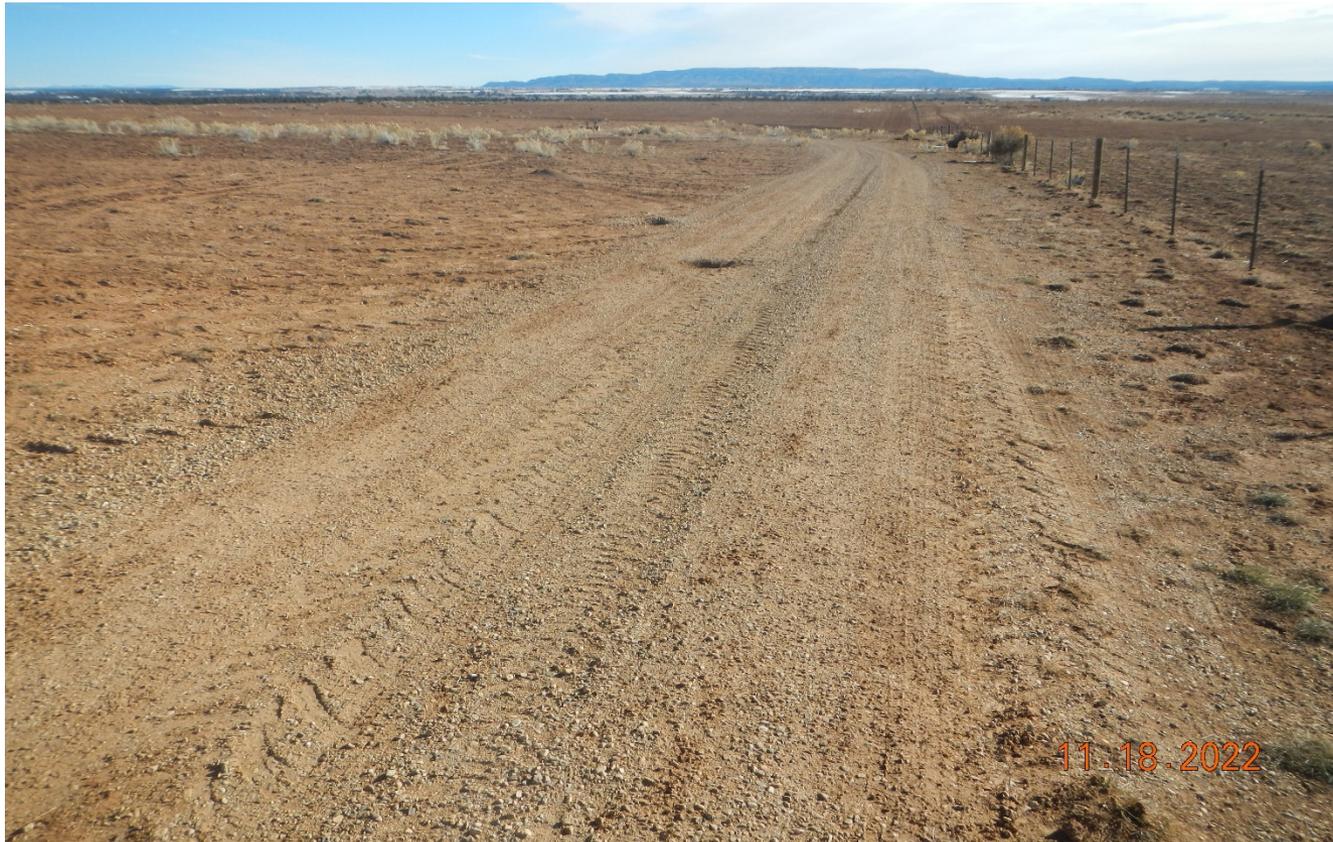
Photo 2. Facing east along the access road which has not been reclaimed and gravel remains.

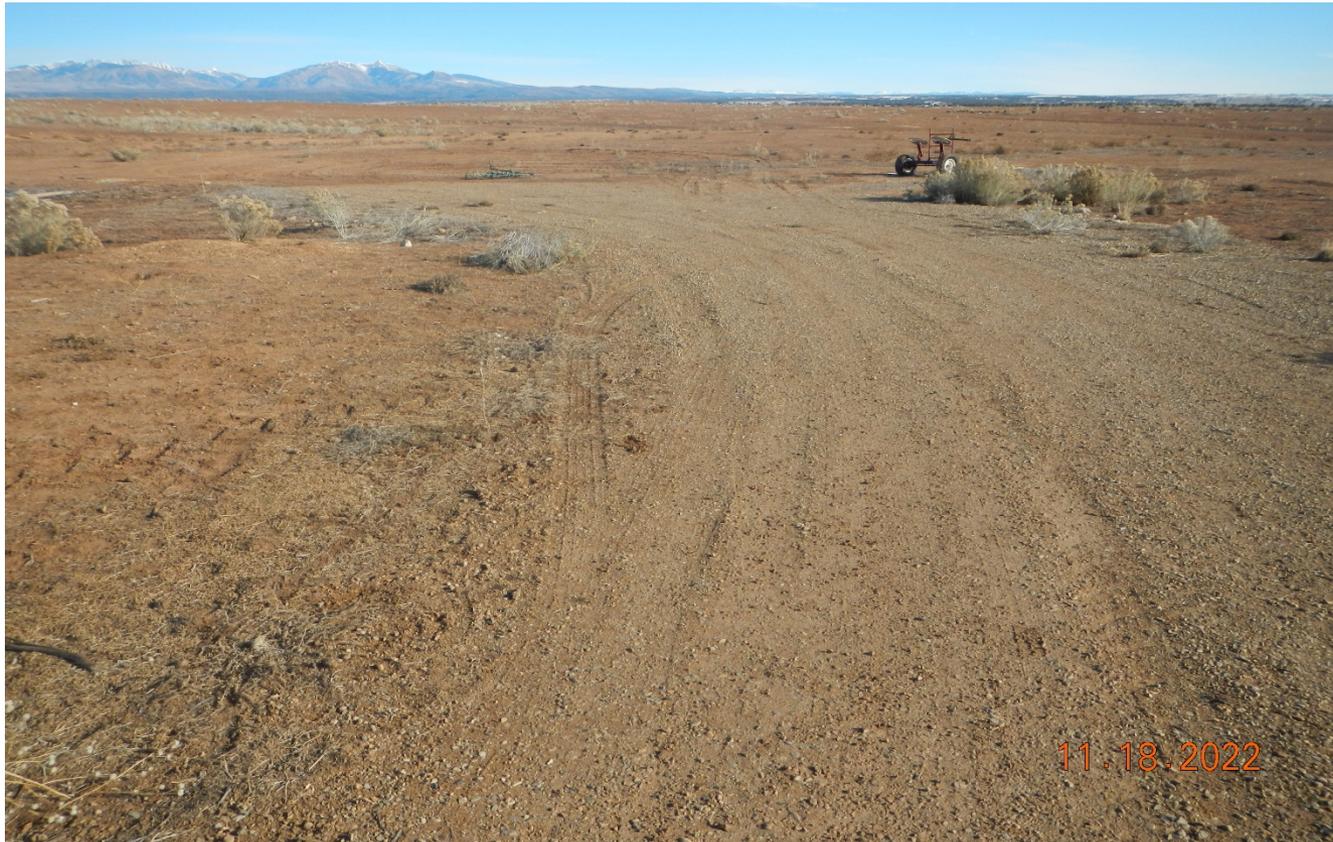
Photo 3. Facing north toward the location which has not been reclaimed and gravel remains.

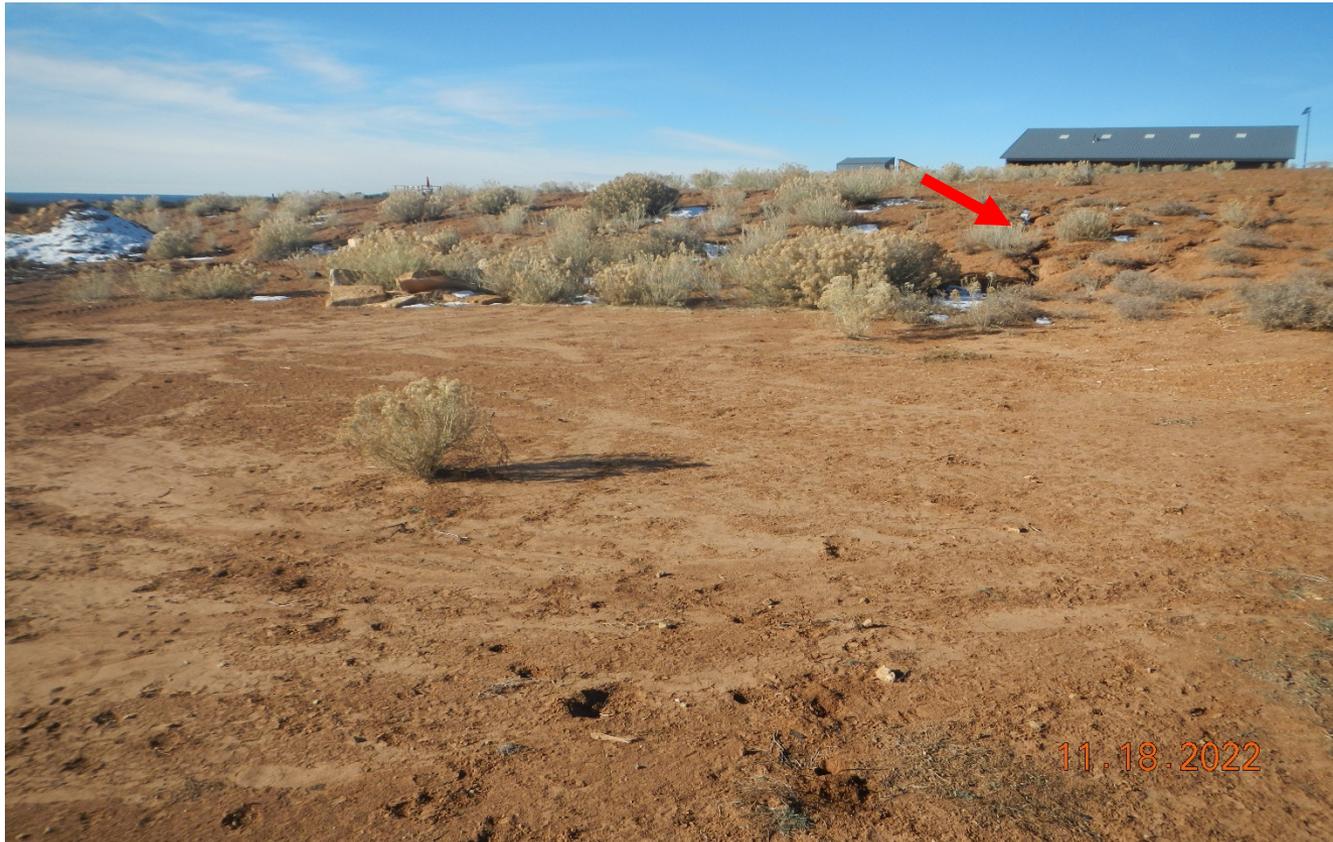
Photo 4. Facing west toward the cut slope which is approximately 6-8 ft. from original grade. There are signs of erosion along the cut slope shown at red arrow.

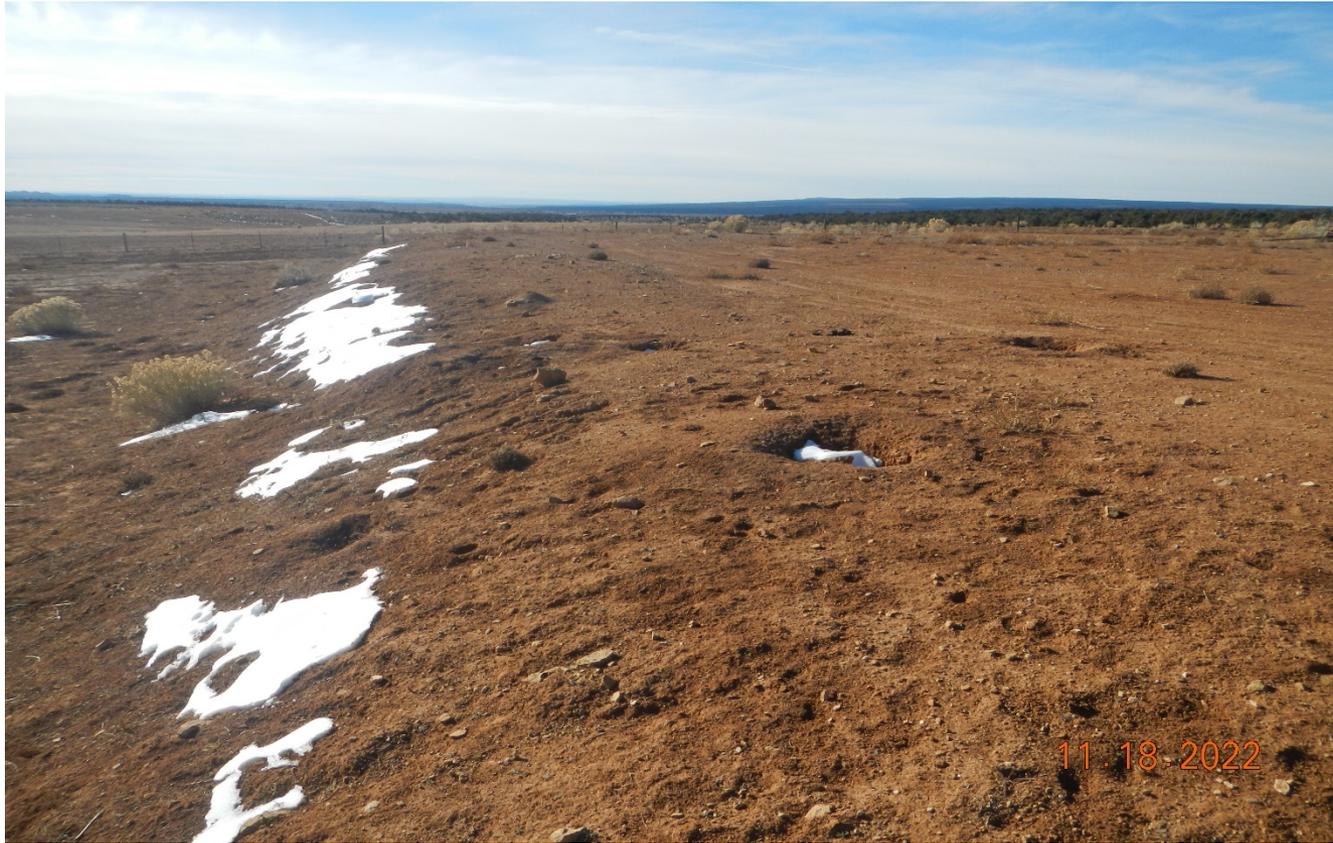
Photo 5. Facing south toward the fill slope at the east side of the location. The fill slope material is approximately 6' from original grade.

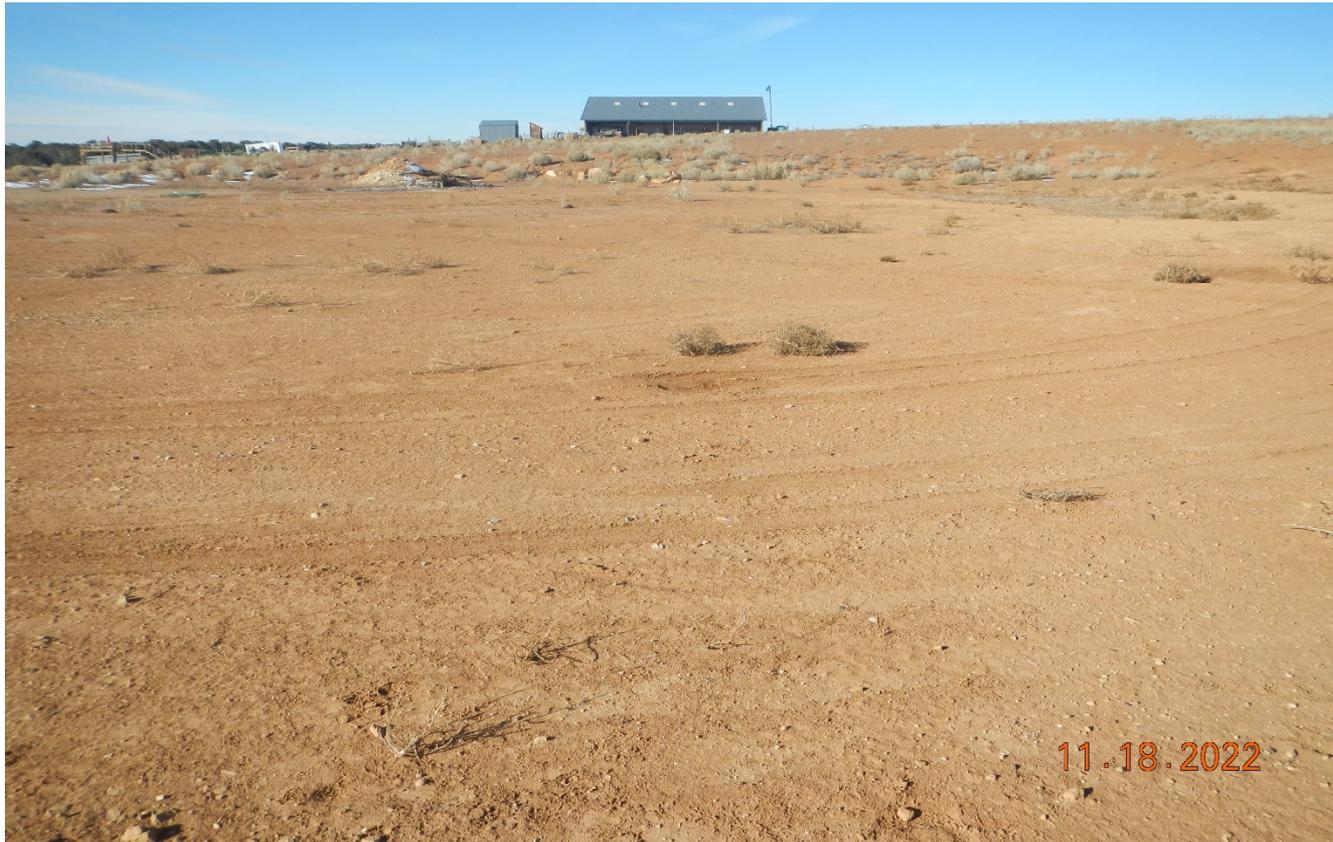
Photo 6. East side of the location facing west. There is minimal to no vegetation growth throughout the location.

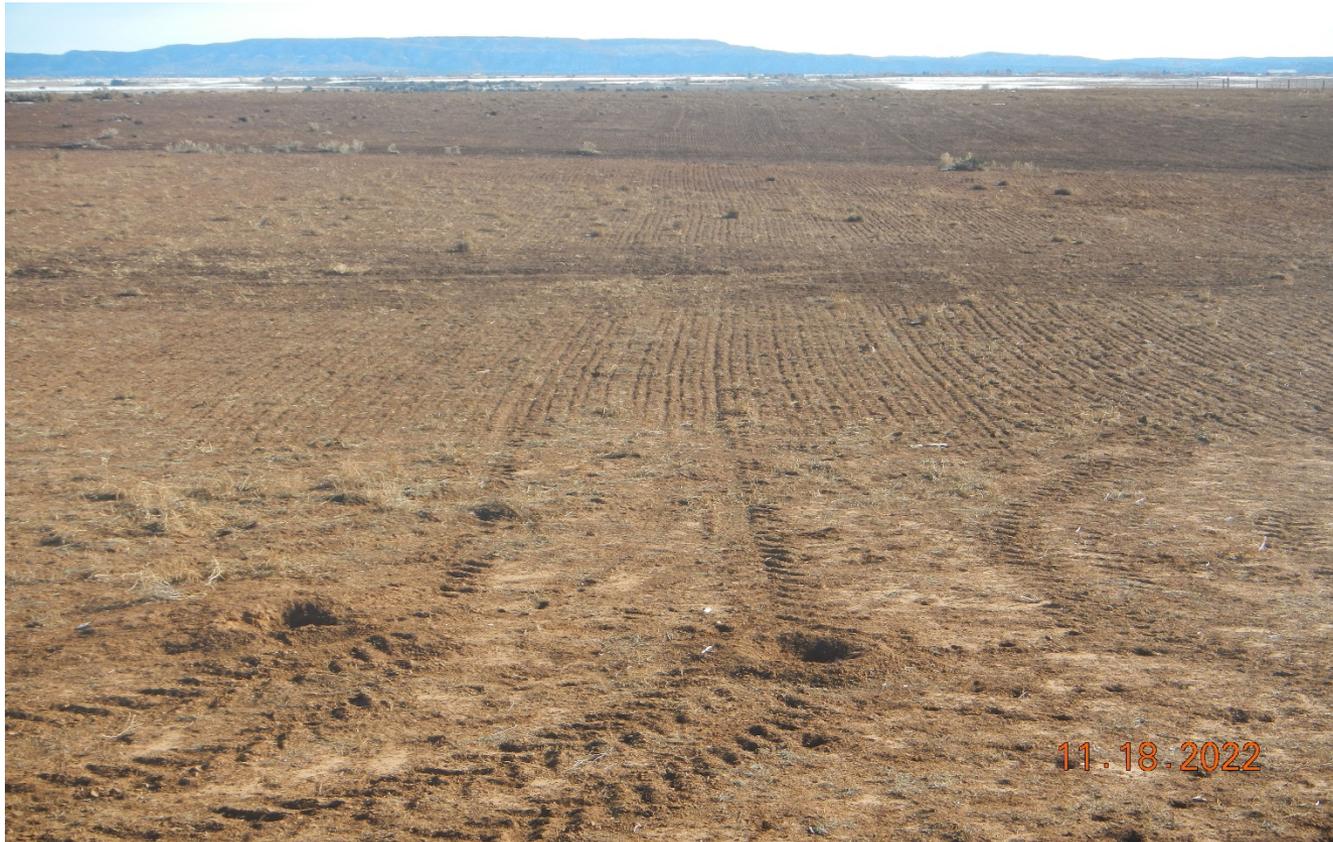
Photo 7. Facing east toward the surrounding field which is farmland that has recently been plant. The location is interfering with farming operations.
