Final Reclamation and Stormwater Inspection

Operator: CUTLER BROTHERS - 22170

Location ID: 319838

NENE Section 32 T1S R66W

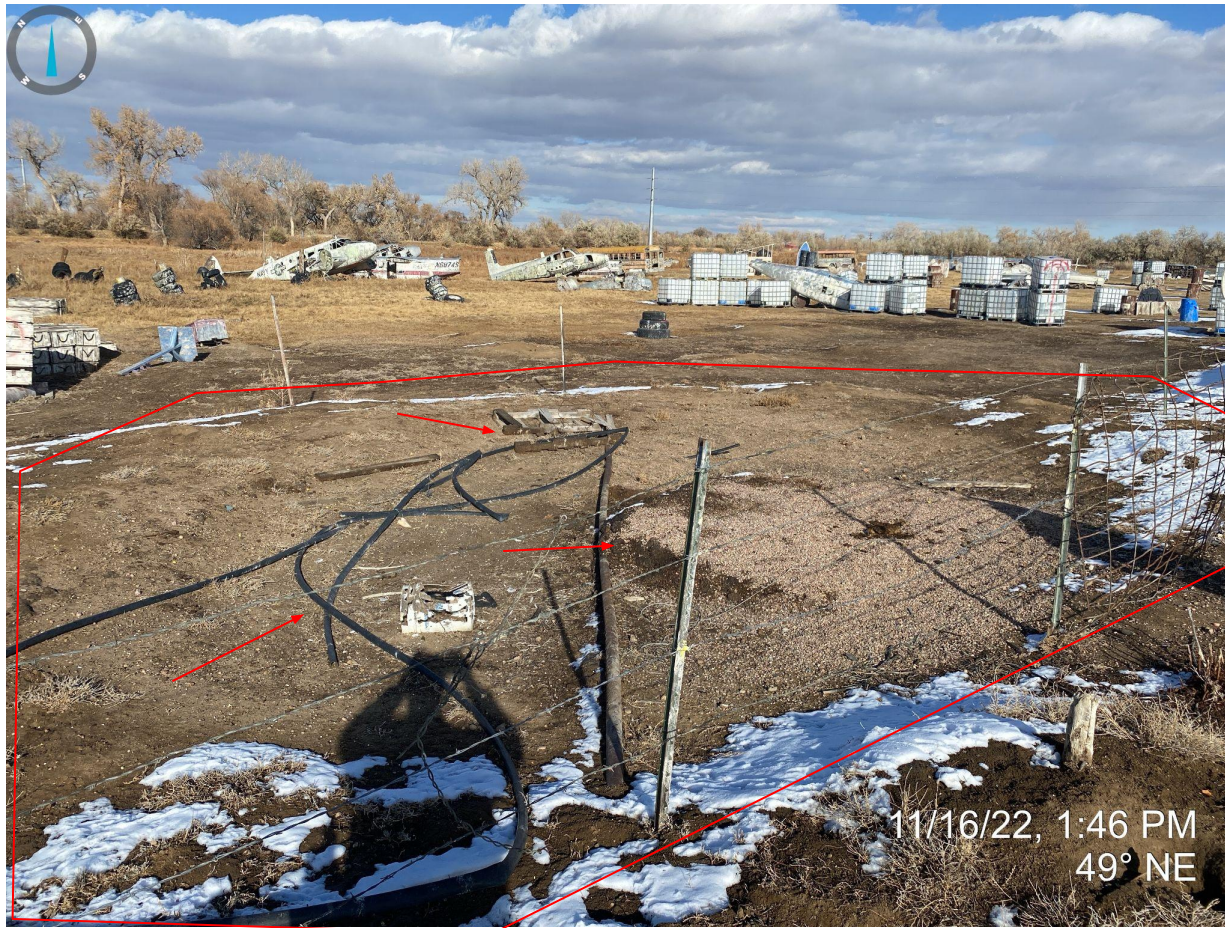
Photo 1. Taken near the former tank battery location, facing northeast. Photo illustrates the tank battery has been removed; various debris (e.g. pipe, fittings, etc) remain on site and need to be removed to comply with Rule 1004.

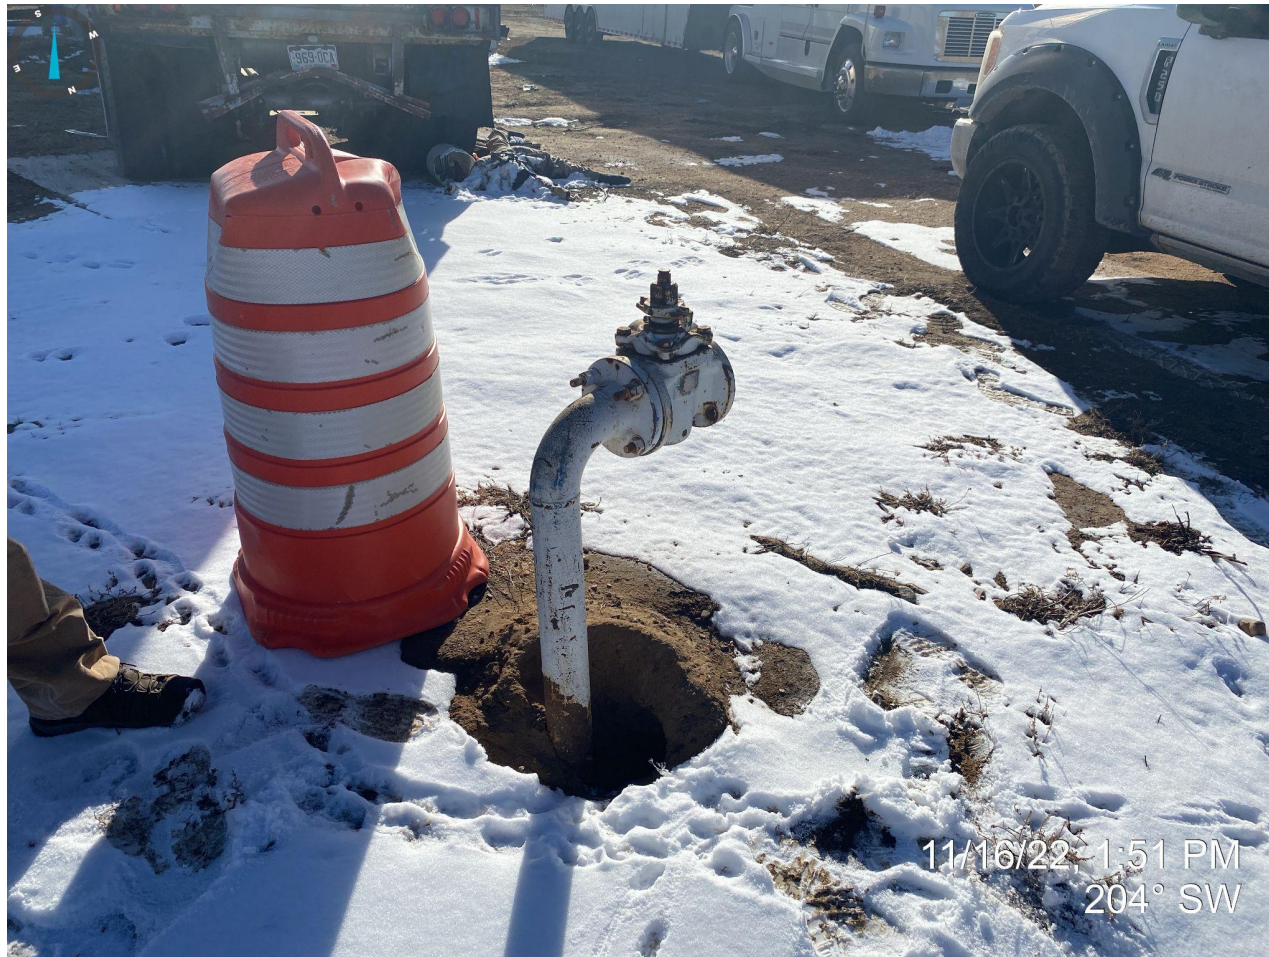
Photo 2. Taken west of the location facing southwest. Photo illustrates a pipeline riser that needs to be removed.

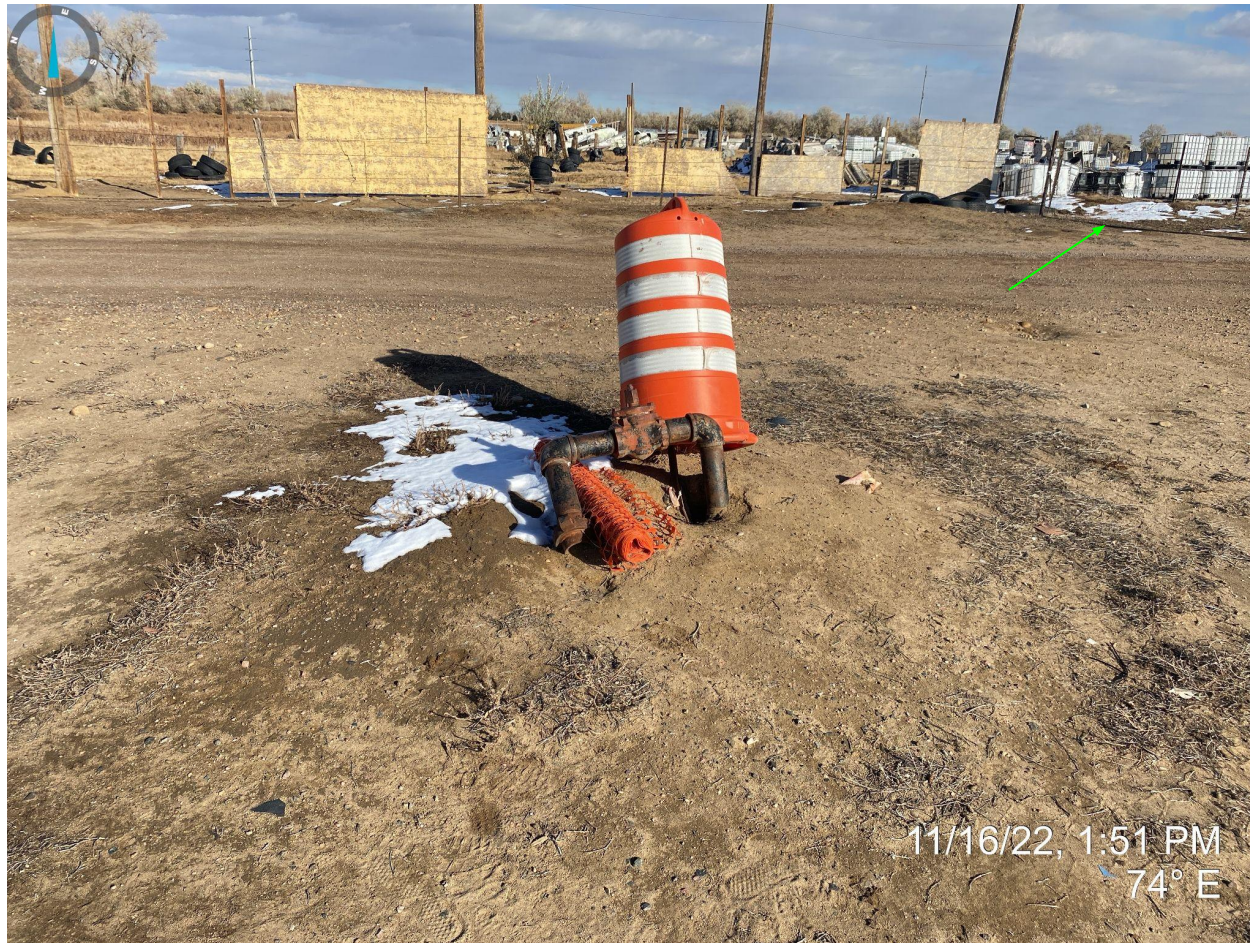
Photo 3. Taken west of the location, facing east. Photo illustrates a pipeline riser that needs to be removed. Green arrow shows former production pit that needs to be closed and approved by a Form 27.

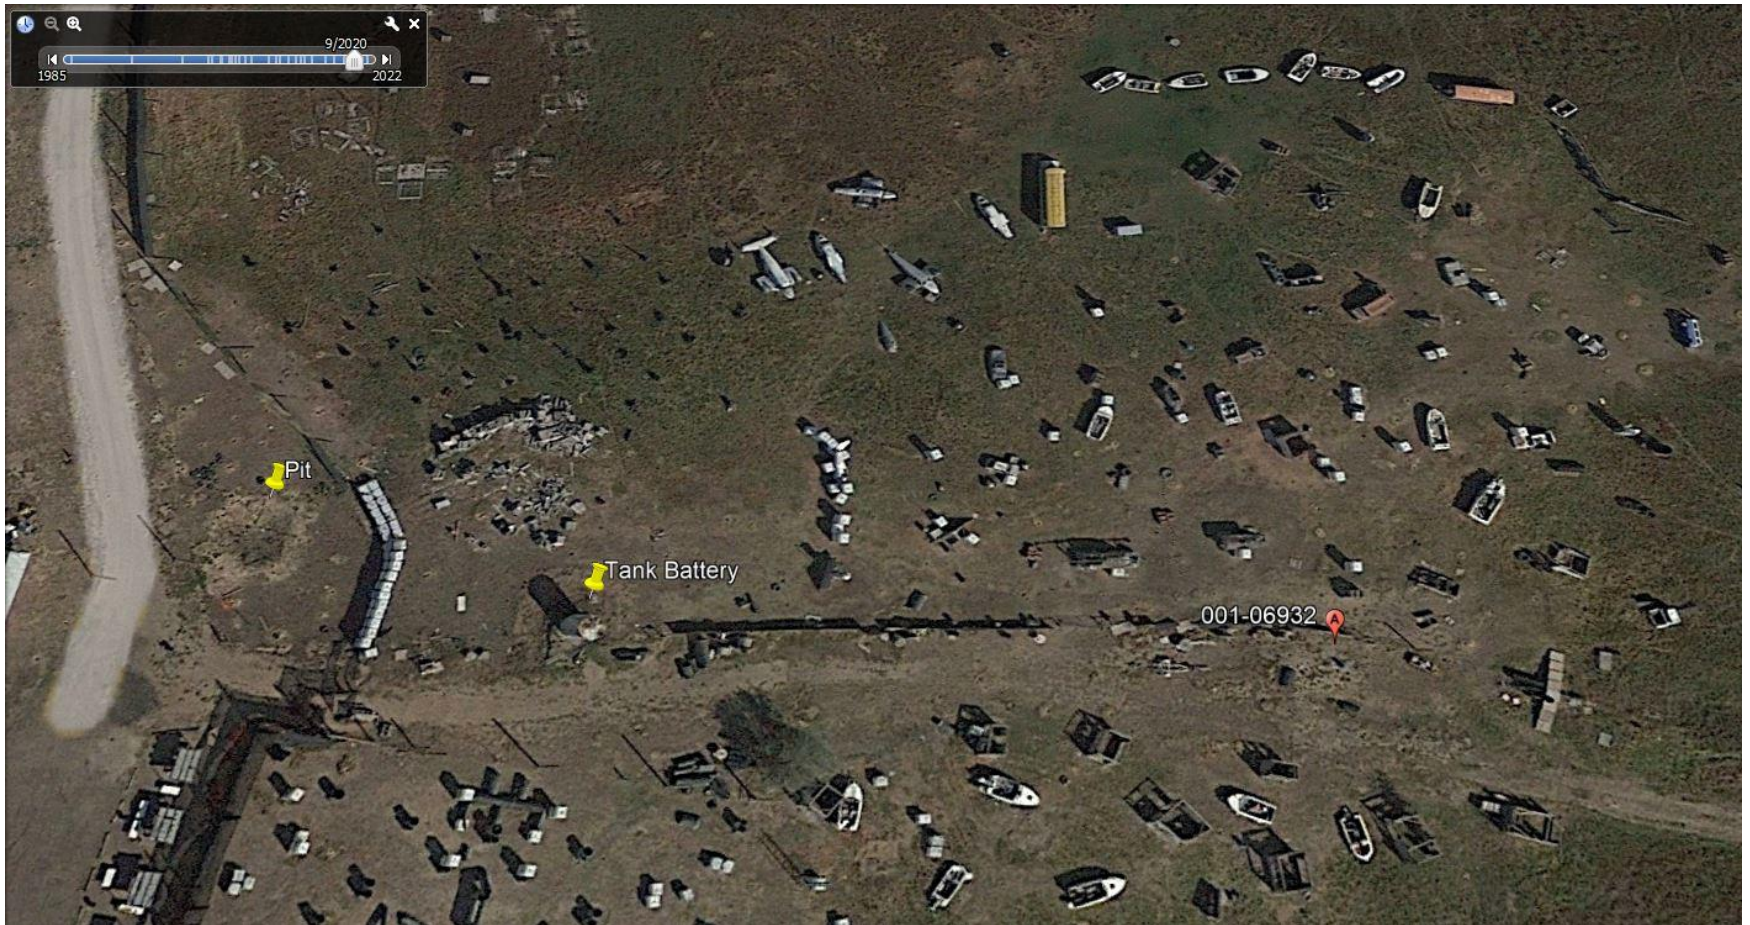
Photo 4. Google Earth aerial imagery taken circa 09/2020 illustrating the well, tank battery, and pit in relation to the current land use, a paintball facility.
