**Operator: EXTRACTION OIL & GAS INC**  
**Location Name: LEECH-61S66W 26NESW**  
**Loc ID: 319807**  
**Inspection: 696105720**

Exhibit A

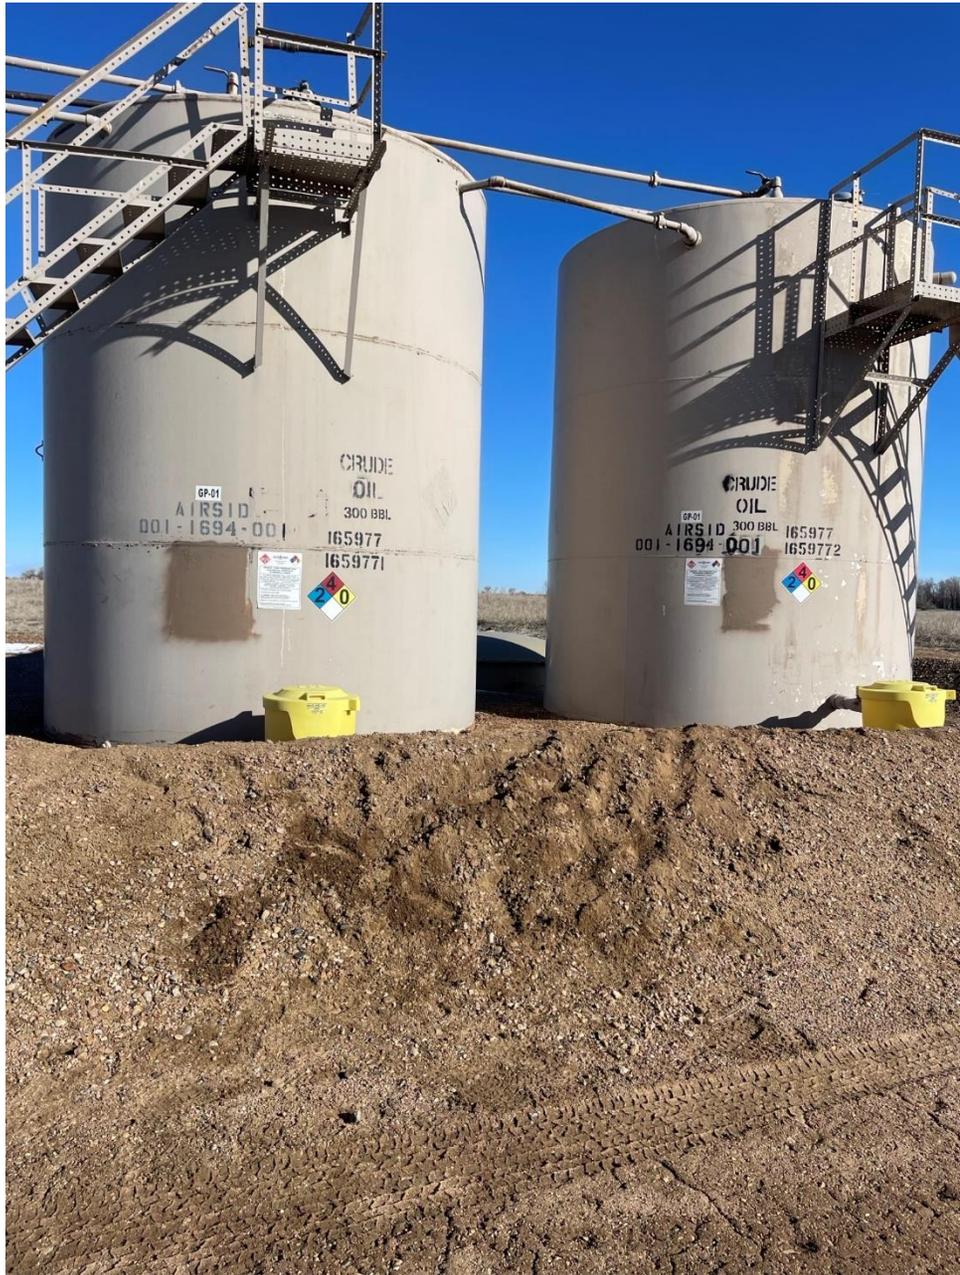
**CA:** NFPA placards and labels at tank battery are peeling, faded, and torn. Refer to attached inspection photos. Install sign to comply with Rule 605.e.

**CA Resolution:** To comply with Rule 605.e, new placards were installed and new stenciled numbers are displayed on tanks.
