SITE-SPECIFIC QUALITY ASSURANCE & QUALITY CONTROL AUDIT

PERMIT CLOSURE REPORT – RANGELAND

Location ID 305223

Location Name DOW LAURA-65N63W/28NESE

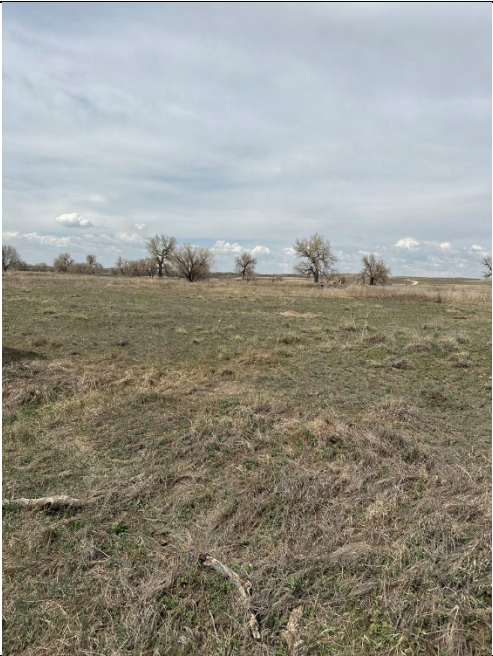
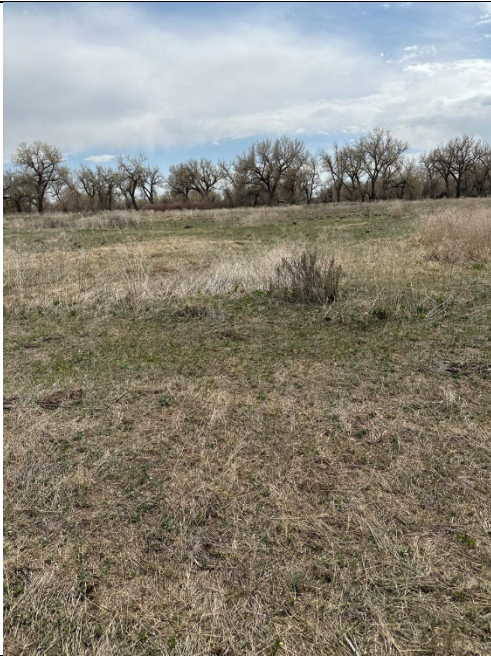
Veg - East	Veg - South

Veg – West	Field Bindweed – <i>Convolvulus arvensis</i> – Colorado List C Noxious Weed

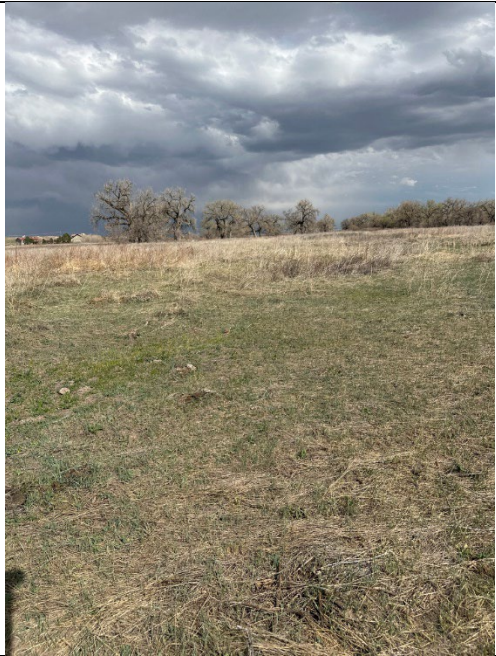
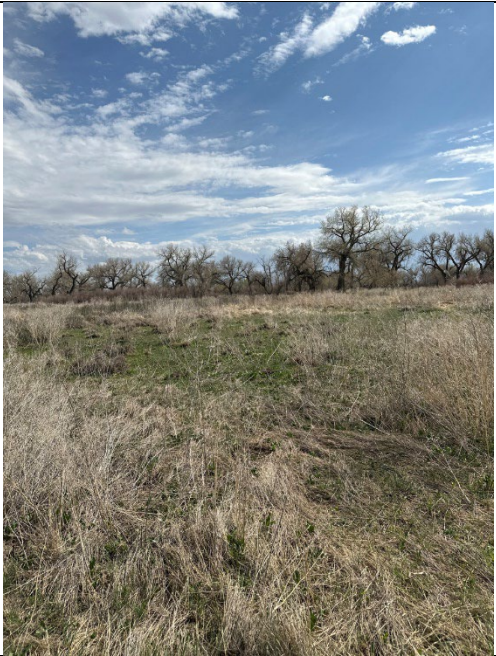
<p>Veg – West</p>	<p>Grass ssp. and Field Bindweed – <i>Convolvulus arvensis</i> – Colorado List C Noxious Weed</p>

<p>Grass ssp. and Field Bindweed – <i>Convolvulus arvensis</i> – Colorado List C Noxious Weed</p>	<p>Grass ssp. and Field Bindweed – <i>Convolvulus arvensis</i> – Colorado List C Noxious Weed</p>

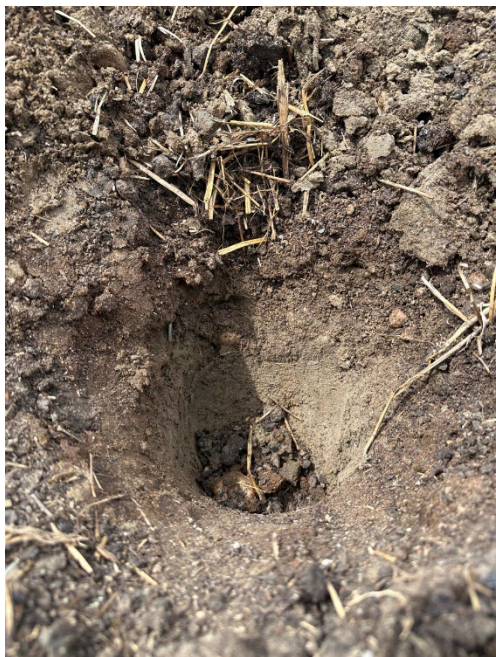
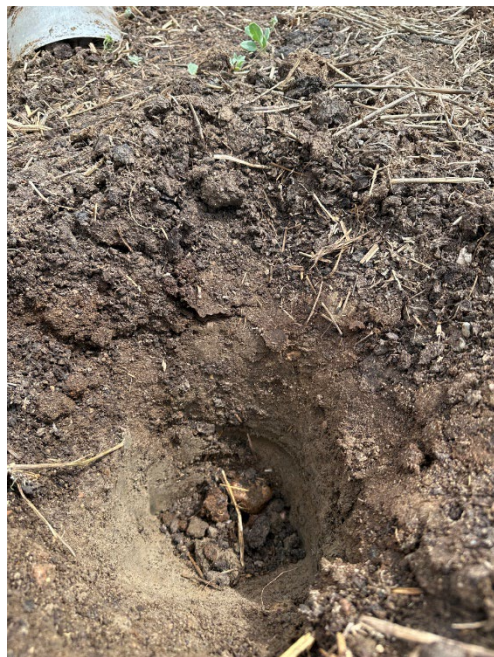
Observation 13 - ROAD- North

Manure in the top 4 inches then compaction

Road: 12 inches remove and replace

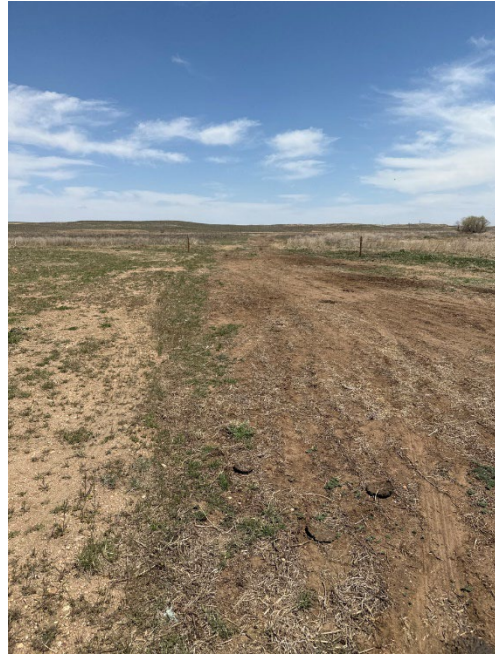
Road

Cheatgrass and gravel
